# Manhole Inspection Summary

Manhole # S13OO1013MH

Insp Date: **11/29/06 10:42 AM**

**Location** Address: **4804 POE AVE**

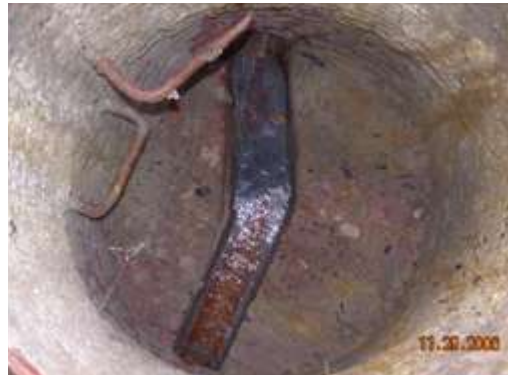
Top View

Corroded steps. Bench debris.

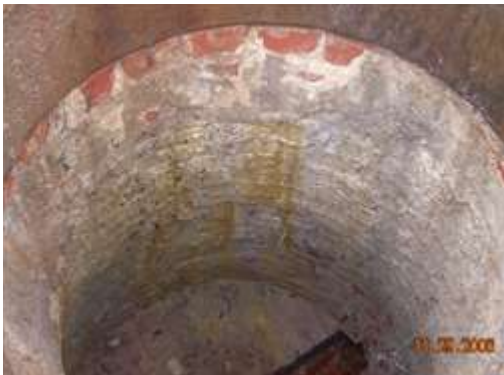
Defect

Frame leaks. Adjustment deterioration and infiltration. Mineral deposits.

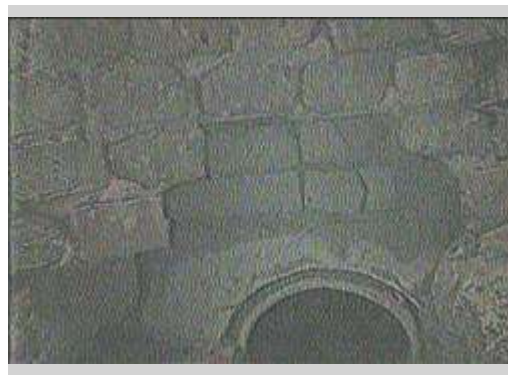
Defect

Barrel deterioration and infiltration.

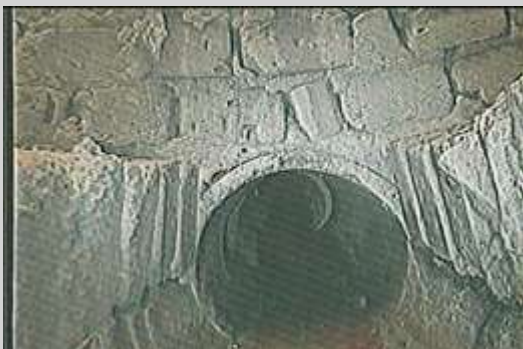
### 8 in. Circular Gravity Sewer Pipe In @ 7 O'Clock

Barrel deterioration and infiltration. Channel deterioration.

Deposits: ☐ None ☐ Mud ☐ Sludge ☐ Debris ☒ Grease

Infiltration: **Evidence** Pipe Seal Cond: **Unknown**
